AVSD-0098-78-RR

TWO POSITION FAIL SAFE SWITCH

Avco Systems Division
201 Lowell Street
Wilmington, Massachusetts 01887

Final Technical Report -- CDRL A004 & CDRL A006

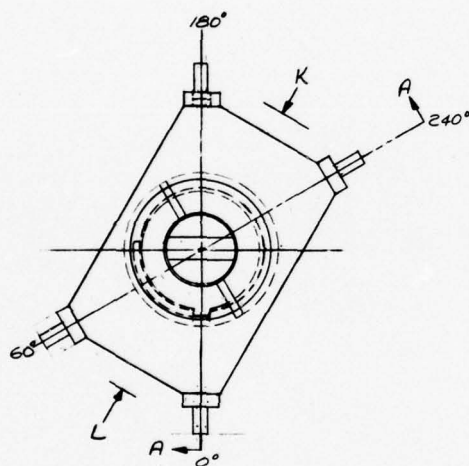
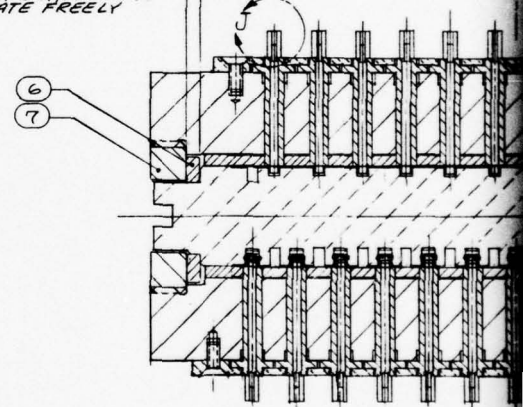
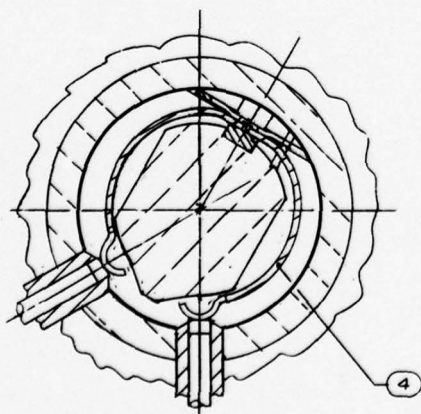
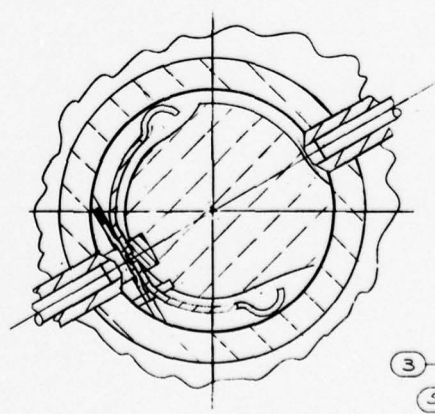
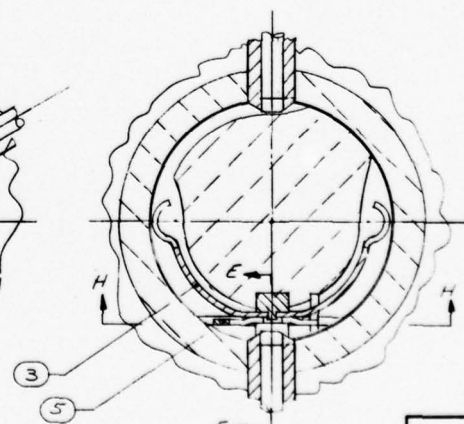
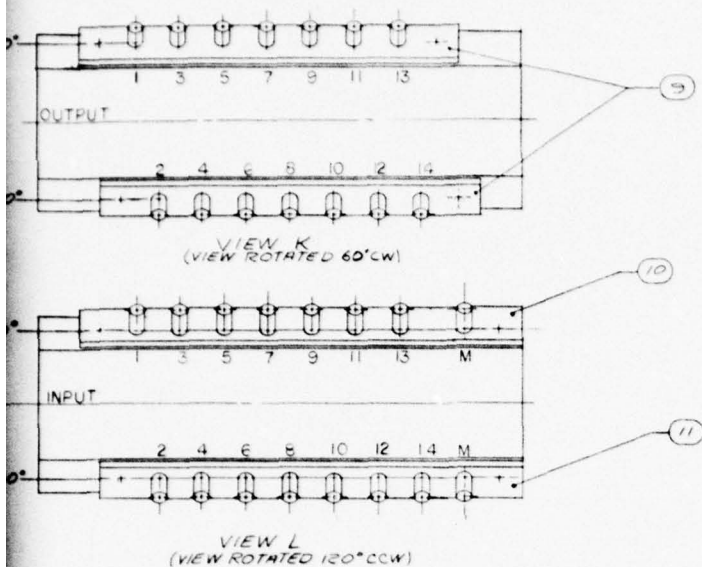
The configuration of the Two Position Fail Safe Switch is shown in Figure 5-1 (LA23527). The switch has 14 normally open functional circuit contacts and one normally closed monitor circuit. The input and monitor contact connections are on two faces, 60 degrees apart, and the output contact connections are diametrically opposite to maintain maximum separation of inputs and outputs. The unit is basically comprised of a strong outer housing structure (1)* made from hardened 4340 steel, and a high strength/high temperature inner rotor (2) made from aluminum oxide (Al_2O_3). An important feature of the design is the minimization of internal voids. The total amount of void volume consist of the slots and grooves machined into the solid rotor.

The 15 movable contact brush assemblies (3 and 4) are shown as Paliney M which is a high temperature noble alloy. It should be noted that BeCu 145/175 is also a candidate for this application (refer to Section 6.2). Each contact brush is mechanically retained in the ceramic rotor by a clip (5) which fits into two slots machined into the rotor, as shown in Sections D-D and H-H (Figure 5-1). The clip and brush combination is under spring load for positive mechanical retention. Each brush assembly fits into a machined rotor cavity, as shown in Sections B-B, C-C, D-D and E-E (Figure 5-1).

The brushes are angularly oriented with respect to the stator contact assemblies (8) by a button which is swaged onto the contact brush and a matching hole in the rotor. A steel shim (6) controls the end play of the rotor and also serves as the rotor angular limit stop. The rotor and shim assembly is secured to the unit by a hardened 4340 bushing (7) which threads into the housing.

*Numbers in parenthesis refer to Figure 5-1 (LA23527).

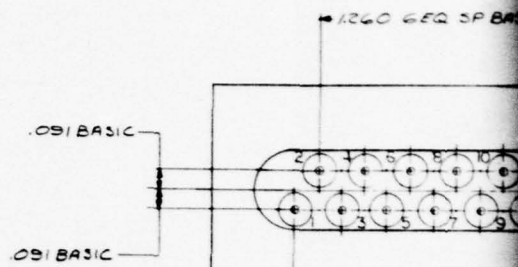
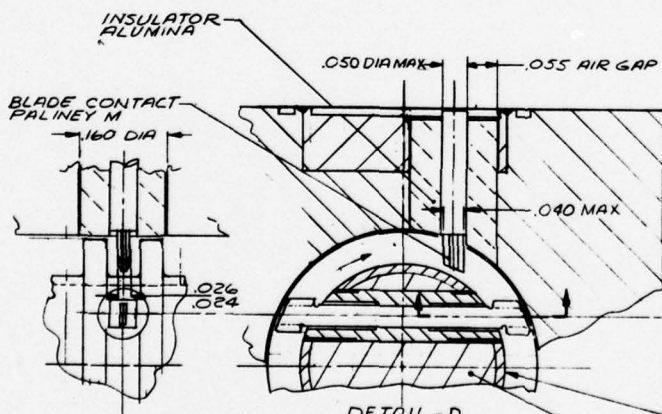
DETAIL - D
SCALE 1/4

HEADER
4340 STEEL
HOUSING
4340 STEEL

INSULATOR, SPRAYED ALUMINA

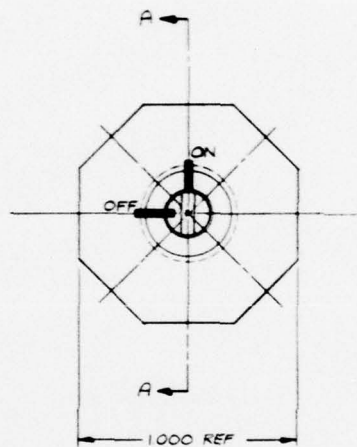
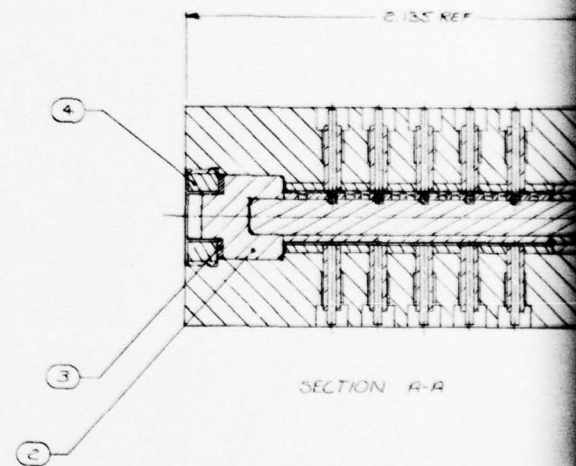
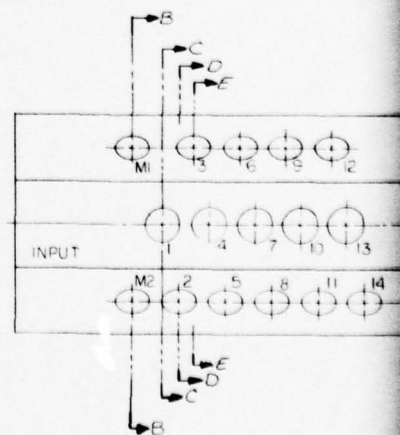
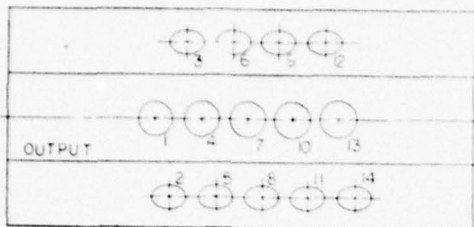
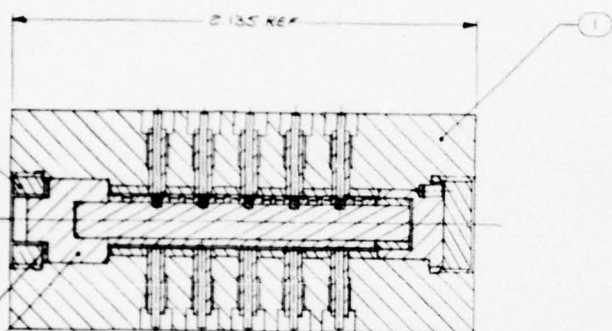
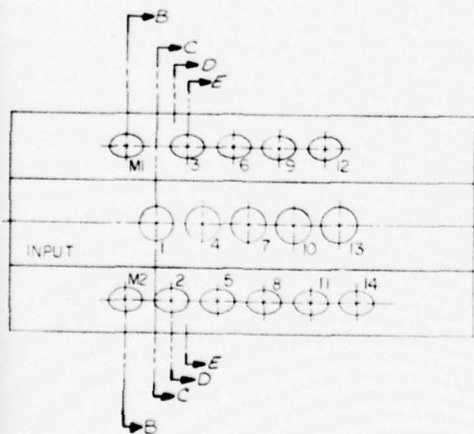
This design configuration is shown in Figure 5-3 (EX23220).

Impact test samples were fabricated to evaluate the impact capability of this configuration. These samples (refer to Figure 6-2) included stator contact holes filled with epoxy (low strength) and molded epoxy rotor to approximate the material configuration.

The octagonal shaped design test units (Figure 5-3, EX23220) exhibited high impact strength capabilities with shear fracture failure characteristics. This failure mode is along a plane containing the stator holes and is located at the maximum shear stress plane (45° from impact surface). However, the octagonal design utilizes a small rotor (.29 diameter) which has several undesirable characteristics (see Section 2.0).

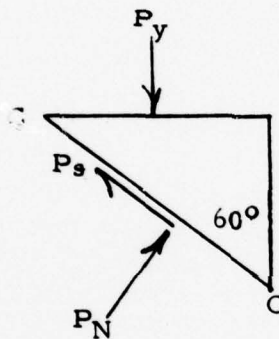
$$P_N \cos 60 = P_S \sin 60$$

$$P_N = P_S \tan 60$$

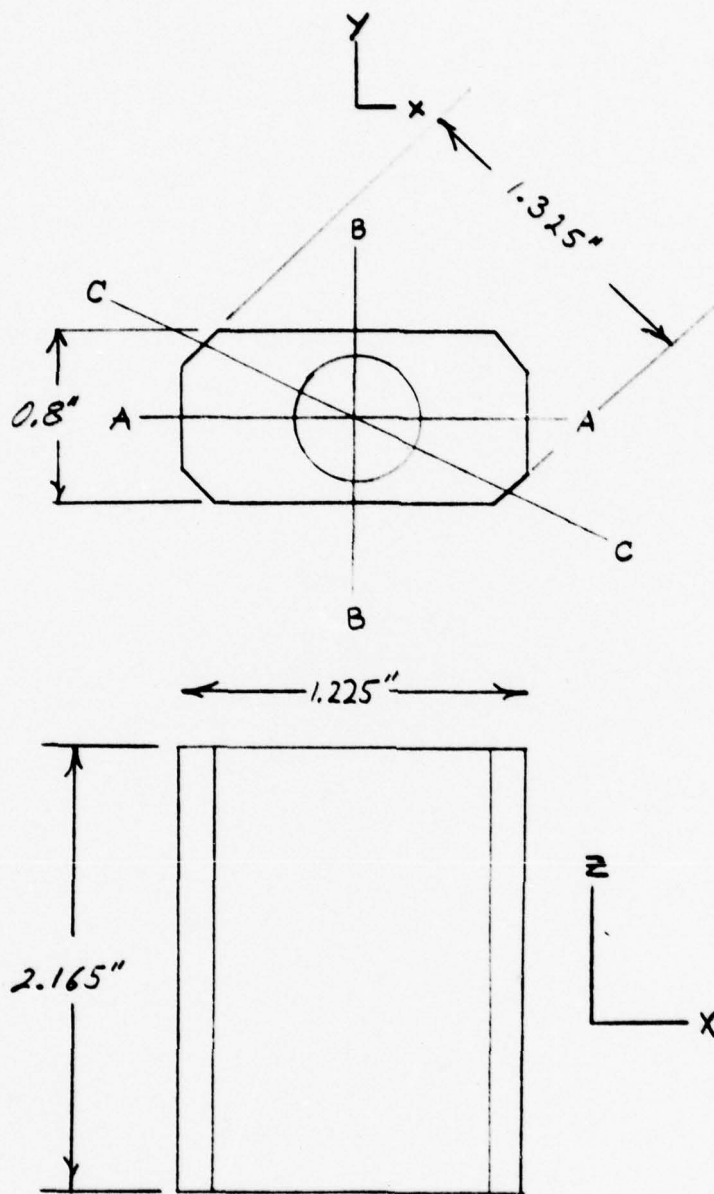
FIGURE 6-1. BASELINE DESIGN

Stress @ Section A-A (Refer to Figure 6-1)

$$\text{Stress @ A-A} = S_{AA} = \frac{P}{A} = \frac{P_y}{2.165 (1.225 - .575)} = .7106 P_y$$

Thus, the units should be approximately as strong as the octagonal shaped units and exhibit a shear type failure. However, because a Y direction load results in a shear stress of 45% of the load, and a X direction load results in a shear stress of 78% of the load, the unit is not as strong when impacted along the X axis. Therefore, the X direction impact capability should be approximately 60% of that of the Y direction impact strength (i. e., $\frac{.45}{.78} \approx .60$).

It should be noted that the baseline design test units were not as strong as the octagonal units when impacted along the Y axis. While a weaker Y impact strength is predicted (see above) the lower level was not expected. An examination of the differences between the two test configurations has shown the following:

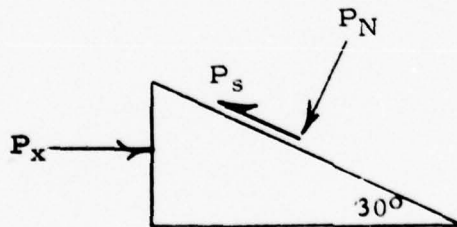
CASE II COMPRESSIVE LOAD P_x (X DIRECTION)

$$P_N = P_S \tan 30$$

$$P_x = P_N \sin 30 + P_S \cos 30$$

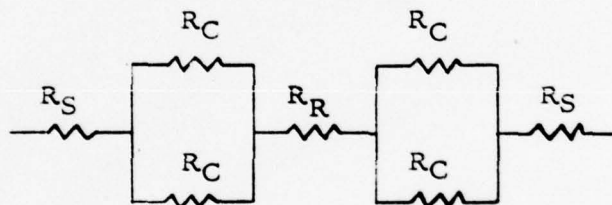
Equivalent Circuit

$$R_{\text{Total}} = 2 R_s + R_c + R_r$$

$$= 2 \times 7.5 + 21.6 + 42.4 = 79 \text{ milliohms}$$

The calculated value of 79 milliohms includes the multiplication factor of 2 to account for circuit degradation with age and cycling.

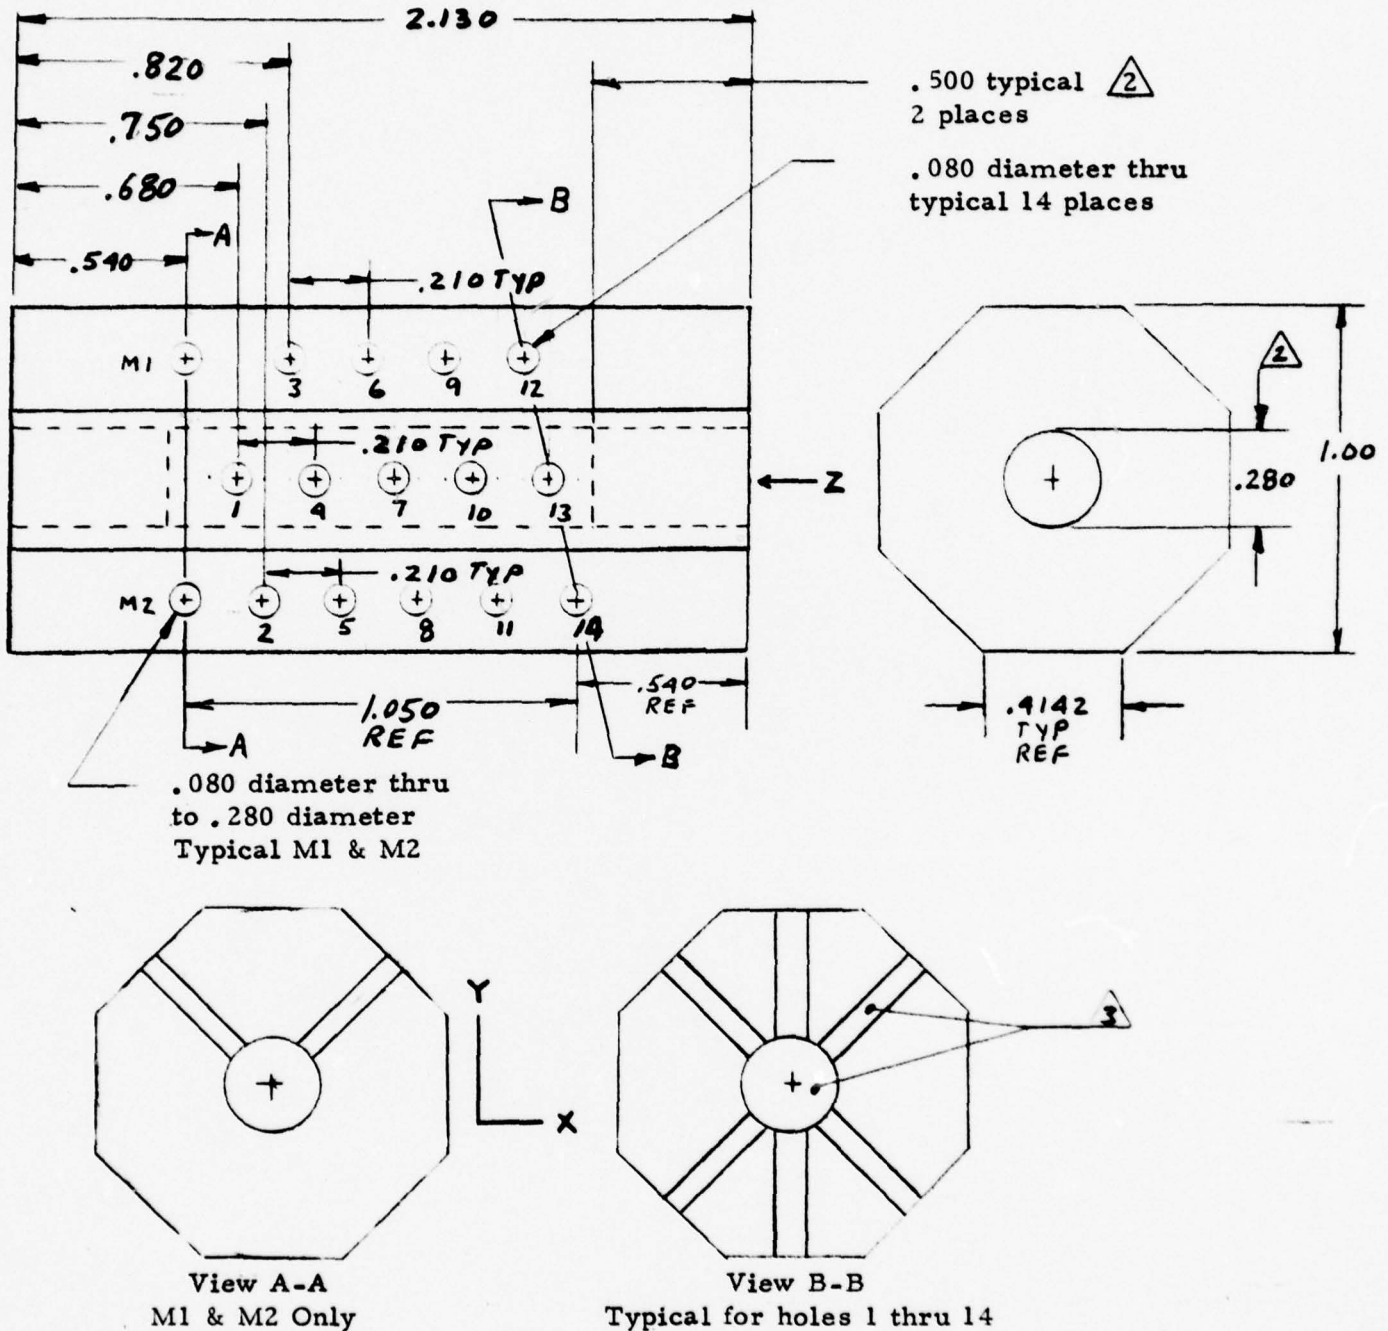
FIGURE 6-2. OCTAGONAL CONFIGURATION

- 1 Material 4340 steel, hardened to Rockwell C53 after machining.
- 2 Drill thru .280 diameter then plug ends .500 deep with material 1. Maximum clearance plug to stator .002.
- 3 Fill all cavities with Hysol Epoxy 1C and cure two hours at 140°F.

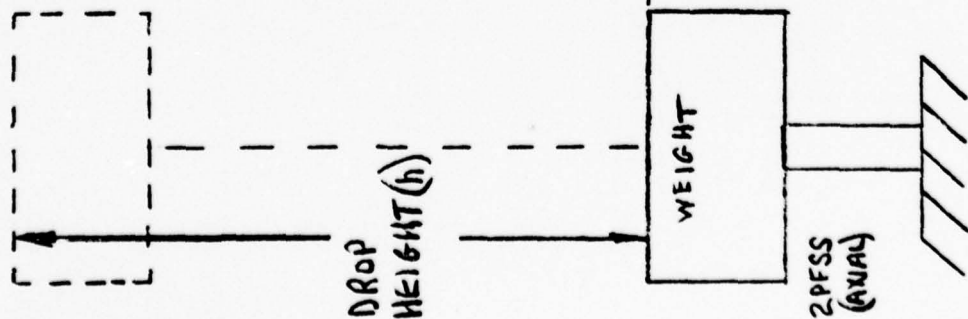
TEST
CONFIGURATION

2 PFSS DROP TEST MODEL

- The instant the weight contacts the switch (at velocity $v_f = \sqrt{2gh}$) the 1 D.O.F. model is initiated.
- The 1 D.O.F. Model is of interest for $1/4$ the period 'T' at which time the maximum displacement is obtained.

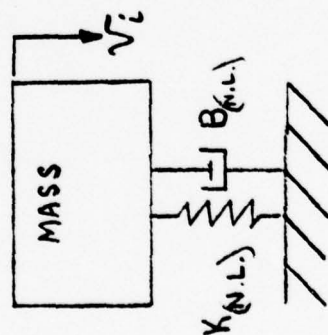
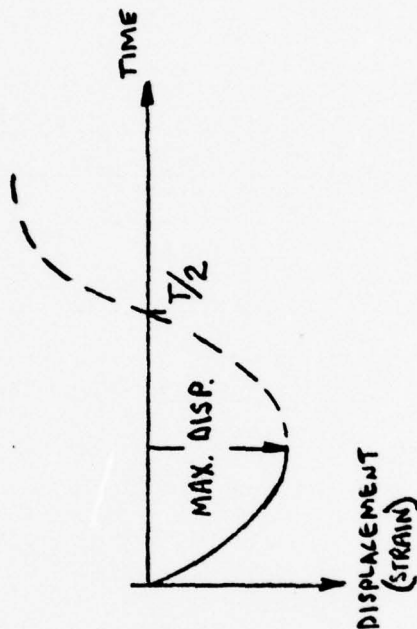
1 D.O.F.
MODEL

- The switch is modeled as a square bar with a hole completely through it.

A single degree of freedom analytical model of the switch was made in an attempt to predict the behavior of the material under the impact mode. The results are presented in Appendix A and indicates that the failure mode may be a function of the applied strain rate and the change in the fracture cross sectional area. Since the mechanism of this cross sectional change is not known, the analysis would have to be refined by several empirical data points. This early analysis showed that the 100 pound weight dropped from 100 feet was more energy than could be absorbed by the switch in the lateral axis and predicated an 80% achievement level.
